RECALL BULLETIN 06V-462

DATE: JANUARY 22, 2007
MODEL YEAR: 2006 thru Early Production 2007
CHASSIS MODEL: UD3300
BULLETIN NUMBER: 06V-462

VOLUNTARY SAFETY RECALL CAMPAIGN NUMBER 06V-462 : ALLISON TRANSMISSION SHIFT LEVER INSPECTION/REPLACEMENT

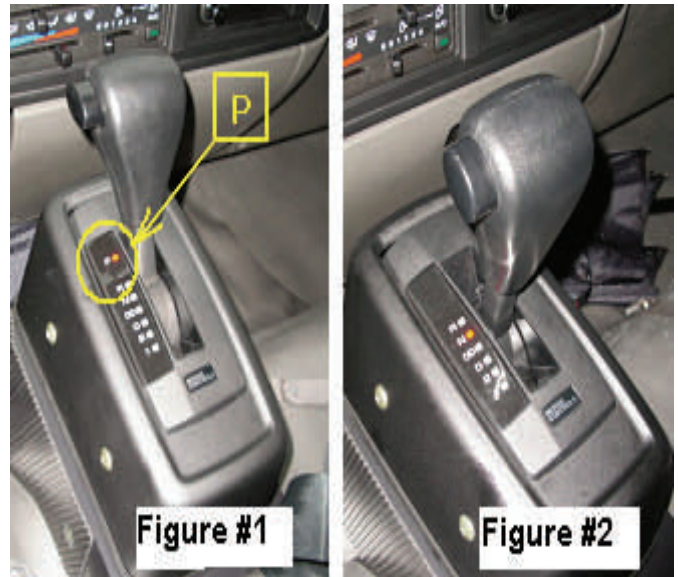
Figure 1 (Incorrect Lever) - With "P" Park position
Replacement of the shifter assembly is required.
Proceed with Step 2 of this bulletin.

Figure 2 (Correct Lever) - Without "P" Park position
No further action is required.
Proceed with Step 4 on Page 5 of this bulletin.

(Incorrect lever)

(Correct lever)
