RECALL BULLETIN 09V-337

DATE: October 5, 2009
MODEL YEAR: 2007 & 2008
CHASSIS MODEL: UD3300 with Locally Installed DUAL STEERING
BULLETIN NUMBER: 09V-337

VOLUNTARY SAFETY RECALL CAMPAIGN NUMBER 09V-337 STEERING STOP ADJUSTMENT

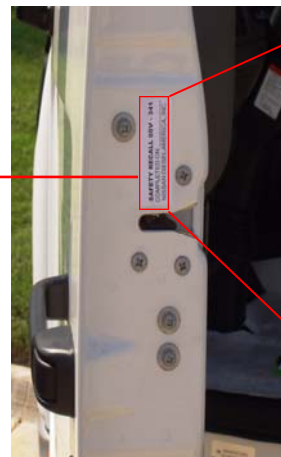
- If the involved vehicle has a label on the inside of the driver's left door as shown in Figure A, the recall has already been performed and no further action is required.
- If the involved vehicle does not have the label on the inside of the driver's door, verify through the Vehicle Service Notification screen of the NDAINET system that the recall is required. Complete the safety recall according to the following instructions.

Step 3) Record the completion date on the Safety Recall 09V-337 sticker as shown in Figure G and apply to the driver's left side door as shown in Figure A on page 2.

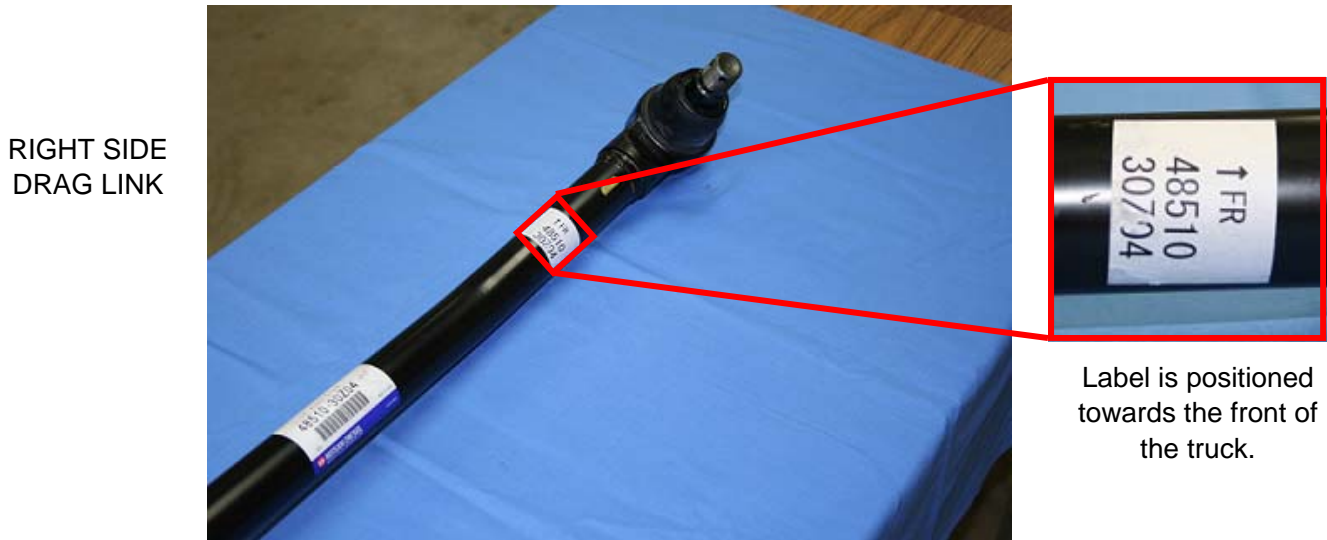
Figure B

The steering drag link directional installation and the stop adjustment on the listed VIN's may be incorrect and may allow the tire to contact the right steering drag link during a full left turn. The incorrect steering stop adjustment may also cause damage to the drag link from tire contact.

- A) The drag link should be installed with the directional arrow and part number label facing the front of the truck. The label may be covered with road dirt and the arrow not visible. The drag link is installed correctly if the label is positioned towards the front of the truck and steering gear. See figure B.

- B) If the drag link is installed correctly proceed to step 2.
- C) If the drag link is installed incorrectly remove the drag link and reinstall in the correct direction as shown in Figure B. Torque the nuts to 159 -253 lb.ft. and install the cotter keys.
- D) If the drag link has been damaged by contact with the tire, install a new drag link part number **4851030Z04**.
- E) Install the new drag link with the directional arrow facing the front of the truck. Torque the drag link nuts 159 -253 lb.ft. and install the cotter keys.
