DATE: DECEMBER 6, 1996
MODEL YEAR: 1995, 1996, and 1997
MODELS AFFECTED: UD1800/UD2300/UD2600/UD3000
BULLETIN #: SC - 216
FILE AT THE END OF THE ELECTRICAL SECTION IN THE TECHNICAL BULLETIN BINDER

VOLUNTARY SAFETY RECALL CAMPAIGN # 96V - 216

CAB FLOOR WIRING HARNESS INSULATION INSTALLATION

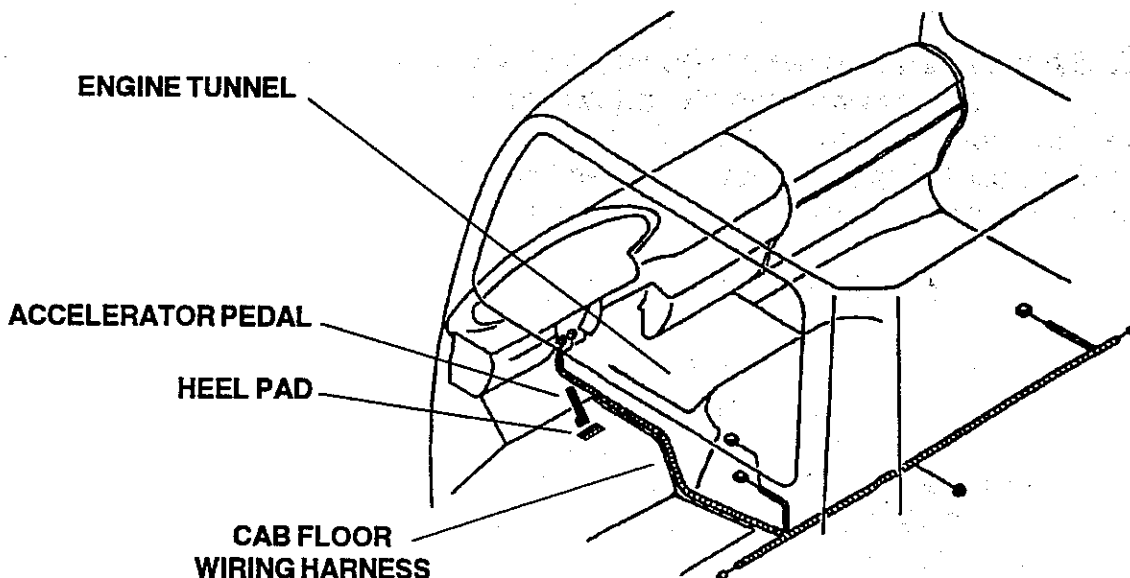
The possibility exists that these vehicles may experience cab floor wiring harness chafing or rub through in the portion of the harness between the driver's seat and the accelerator pedal causing possible breakage of the wiring harness and exposure or breakage of the wiring. Breakage of the wiring could cause loss of electrical power to various vehicle components or systems, including the windshield wipers.

The repairs to correct this condition consist of installing double-layered corrugated insulator tubes and padded insulated tape on the cab floor wiring harness. If any of the wires in the harness have been broken, they should also be repaired.

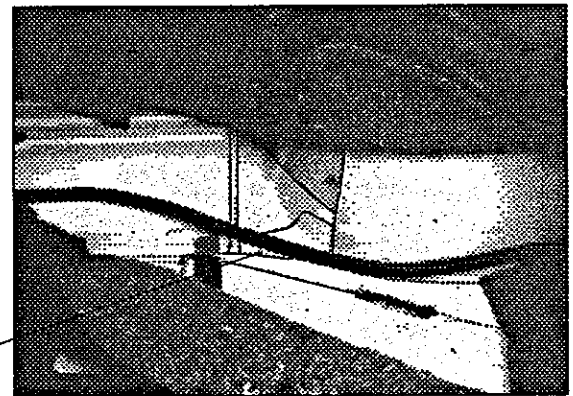
Note location of floor panel seam at base of shift tower.

3. Install the small diameter corrugated tube over the wiring harness from the accelerator pedal to the driver's seat base. Push the tube all the way down the length of the harness between the driver's seat and the engine tunnel as far back as possible.

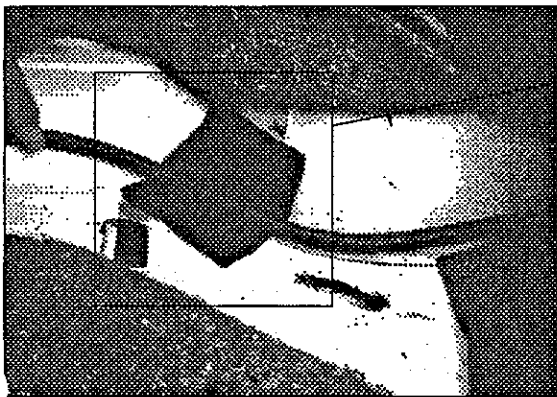
NOTE: The padded insulated tape acts as a friction insulator between the wiring harness and the floor panel seam.

6. Apply one piece of square padded insulated tape to the floor panel seam at the base of the shift tower, as shown in the figure on the left.
