SUBJECT: Water Entry into Clutch Housing.

Department: Service
Section: Clutch
Model(s): All w/Manual Transmission
Model Year(s): 2011 and after
Effective Date: 01/01/2012
Form #: TSB CL-08
Rev #:
Supersedes:

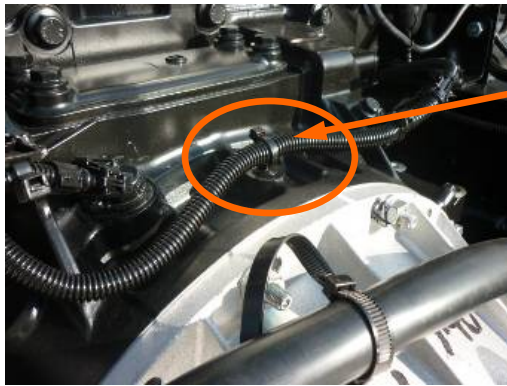
(Figure 1)

To advise dealers the procedures to correct water entry into the clutch housing. This condition may occur on manual transmission vehicles without a body that are in a storage area exposed to outside weather conditions.

1. Cut and remove the plastic tie strap PN# 5200980881 securing the wiring harness to the top of the flywheel housing. (Figures 1 & 2)
