URGENT SERVICE ADVISORY

To all owners and operators of Nissan Diesel CK330, CW330, CW380, CW400, CG380 & CG400 vehicles manufactured between 1993 and 2005.

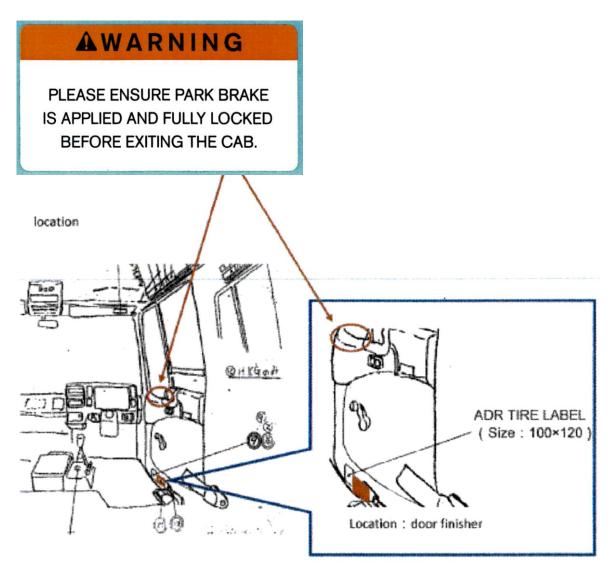
TO FIT THIS LABEL

- 1. Ensure that the surface is clean and free of dust. If necessary wipe with cleaning solution.
- 2. Peel backing from label and apply firmly to the area indicated.

As a reminder to the drivers of these vehicles to ensure that the park brake is correctly applied and locked before exiting the cab, UD Truck Distributors has produced a warning label to be placed in the cab. See fitting instructions included.
