**SUBJECT: Voluntary Safety Recall Campaign Number 11V-177  
Horizontal Headlamp Adjustment Mechanism**

Department: Service  
Section: Electrical  
Model(s): ALL  
Model Year(s): 2011  
Effective Date: April 9, 2011  
Form #: Recall Bulletin 11V-177  
Rev #: N/A  
Supersedes: N/A

Specific 2011MY UD1800, UD2000, UD2300, UD2600 and UD3300 model vehicles within the vehicle identification number ranges listed below.

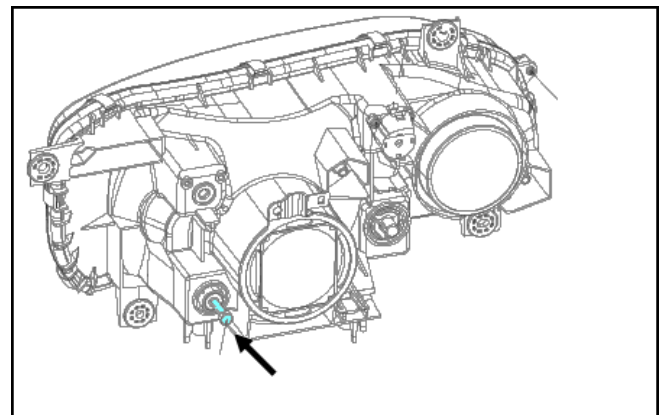
- From the backside of the headlamp assembly, locate the horizontal adjustment screw. This will be on the outboard side of the headlamp capsule.

Left side assembly shown in illustration.

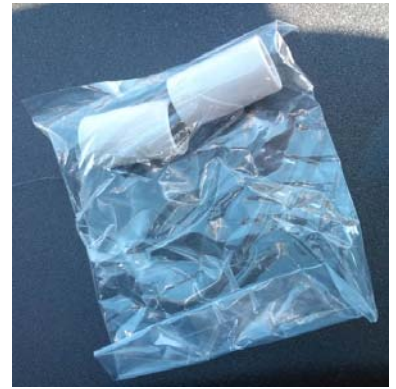
- Locate the plastic prevention caps placed in the overhead compartment at time of manufacture.

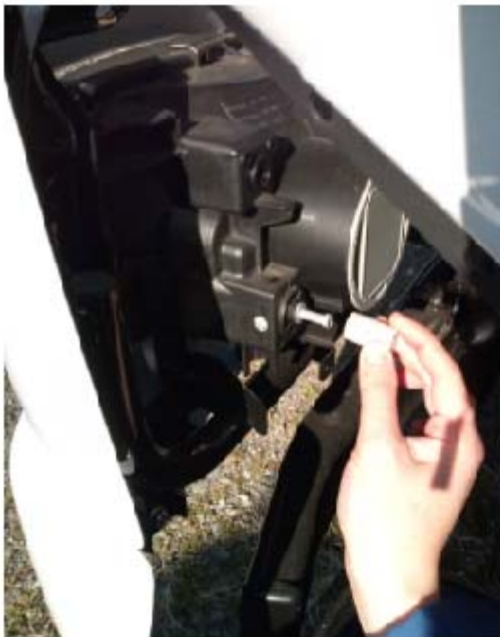
Left Side

- Install the plastic prevention cap over the horizontal adjustment screw as illustrated:

**NOTE:** When installing the caps, push firmly until it clicks into place.
