RECALL BULLETIN 06V-462

DATE: JANUARY 22, 2007
MODEL YEAR: 2006 thru Early Production 2007
CHASSIS MODEL: UD3300
BULLETIN NUMBER: 06V-462

VOLUNTARY SAFETY RECALL CAMPAIGN NUMBER 06V-462 : ALLISON TRANSMISSION SHIFT LEVER INSPECTION/REPLACEMENT

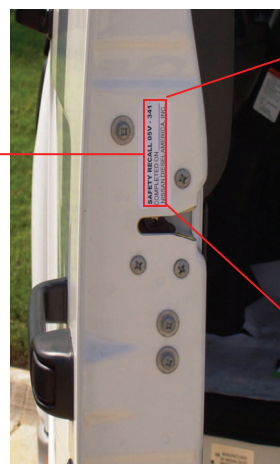
Figure A

- If the involved vehicle has a label on the inside of the driver's door as shown in Figure A, the recall has already been performed and no further action is required.
- If the involved vehicle does not have the label on the inside of the driver's door, verify through the Vehicle Service Notification screen of the NDAINET system that the recall is required. Complete the safety recall according to the following instructions.

**SAFETY RECALL 06V-462
COMPLETED ON
NISSAN DIESEL AMERICA, INC.**
