# TECHNICAL BULLETIN

DATE: JUNE 20, 1995  
MODEL YEAR: 1994 - 1995  
CHASSIS MODEL: UD1400  
BULLETIN #: TR - 08  
**FILE IN THE TRANSMISSION SECTION**

## **MES50 (B) (C) REVERSE SYNCHRONIZER STOPPER WASHER**

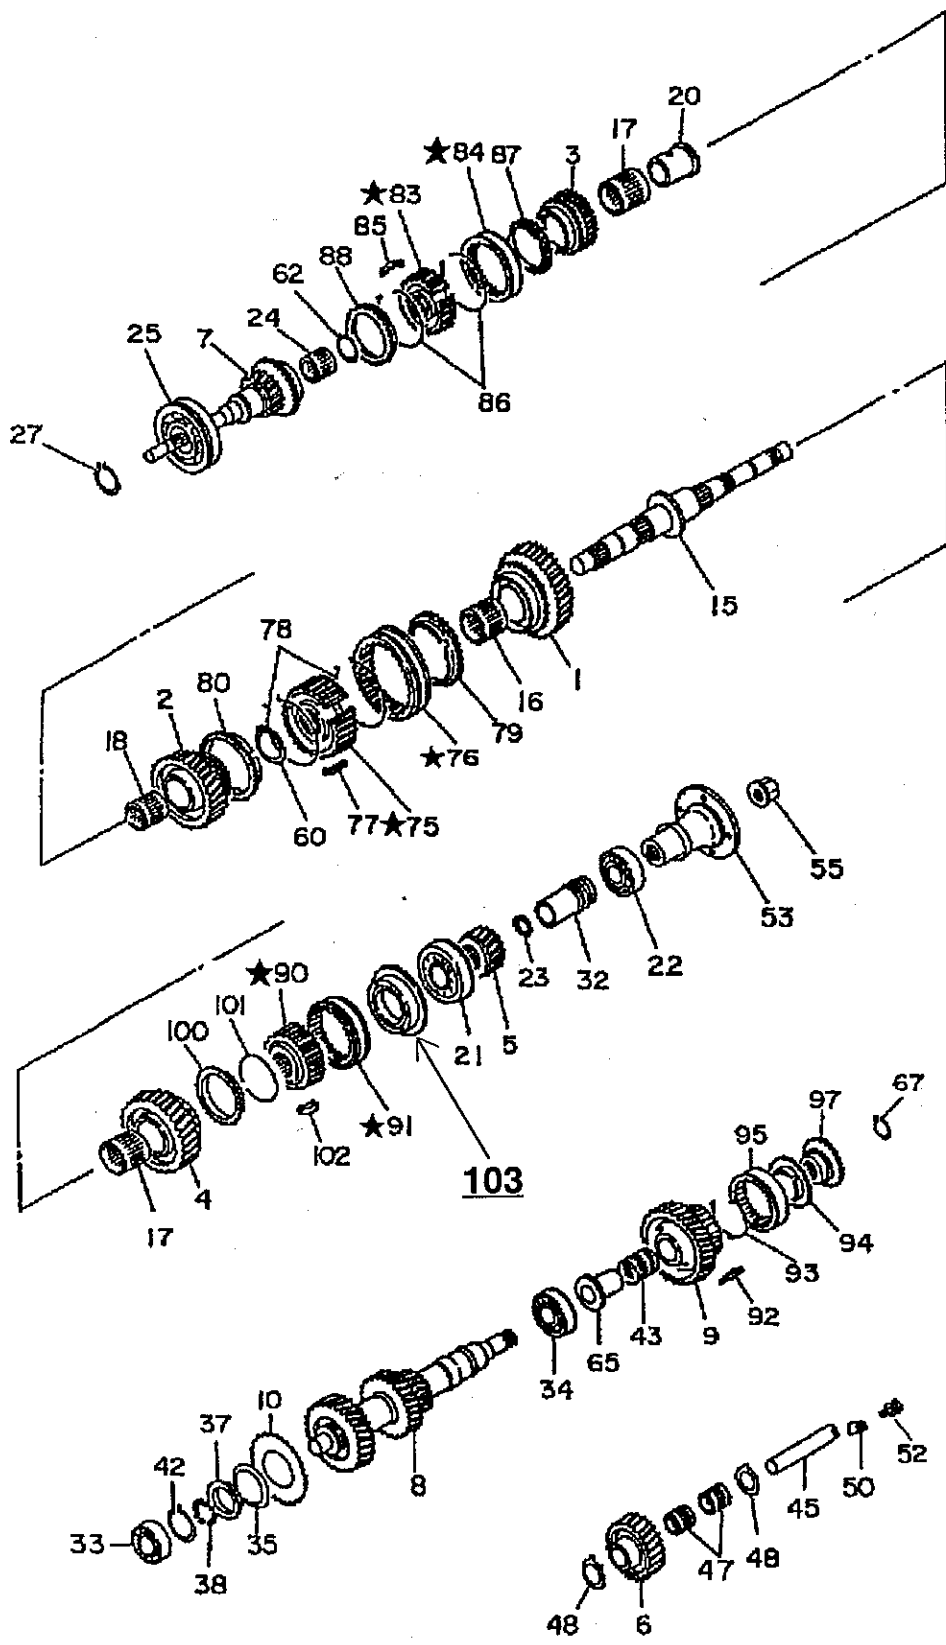
The reverse synchronizer ***stopper washer is press fitted*** on the back side of the ***reverse synchronizer hub*** and it serves the purpose of retaining and securing the detent blocks and detent block tension spring in place; see item number **103** in the figure on the reverse side of this page. The front tension spring in the reverse synchronizer is held in place by the reverse baulk ring.

The UD1400 Service Manual ***does not list the reverse synchronizer stopper washer*** in the mainshaft exploded view. UD Dealers should make a manual correction to their UD1400 Service Manual page MT-5-4 to include this item in the drawing.
